HELVELY PARK DAM

CLAY COUNTY, MISSOURI

MO 10584

PHASE 1 INSPECTION REPORT NATIONAL DAM SAFETY INSPECTION

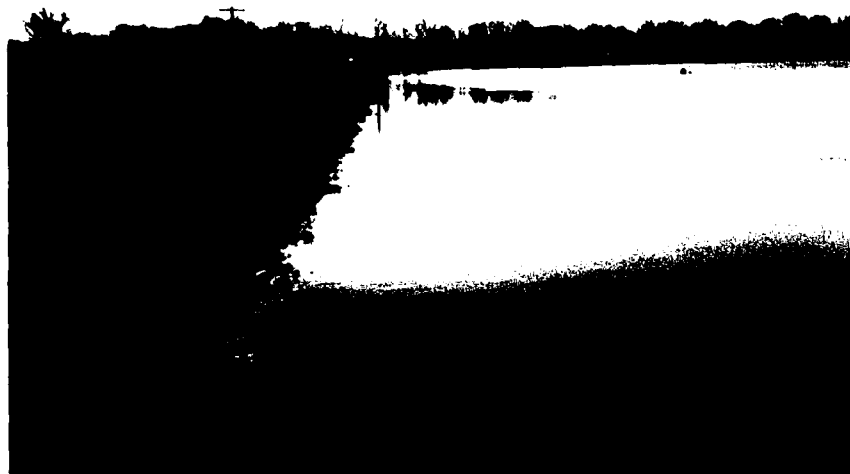
PHOTO 4: UPSTREAM FACE OF DAM FROM NORTHWEST END

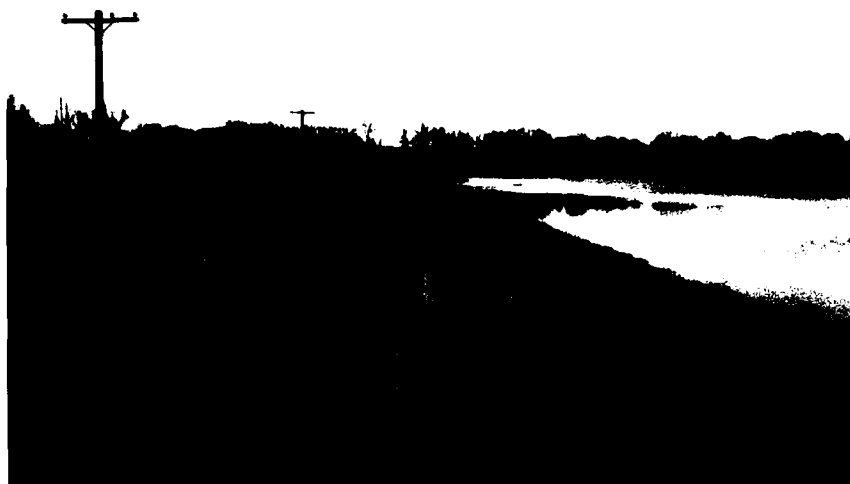
PHOTO 5: CREST OF DAM FROM NORTHWEST END

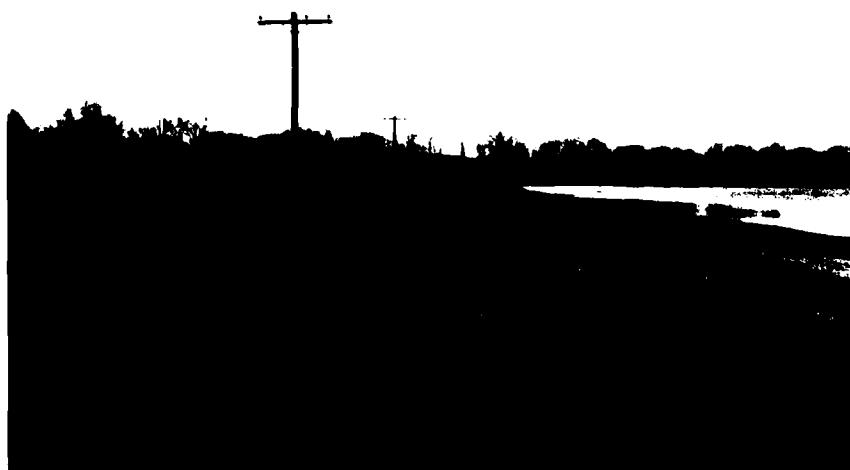
PHOTO 6: DOWNSTREAM SLOPE OF DAM FROM NORTHWEST END
